**Flood Control Project Maintenance
Levee Inspections**
LMA District Cover Sheet
Spring 2019 Levee Inspection Results

Reclamation District No. 1001 Nicolaus

Spring 2019 Levee Inspection Results

Waterway	Bank	Unit Miles
Unit No. 01 Yankee Slough	Right	4.12

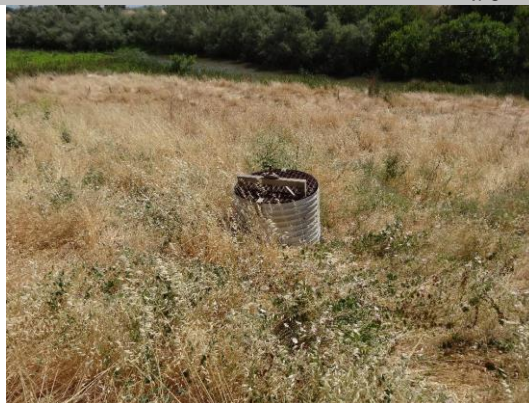
Photo 1 of 3 : UCIP_SP_2019_53425_22046.jpg

Comment Code					
Inspector Comment					
FS_ID:53425 DS_ID:22632 EP_NO: N/A Repair Type: Urgent Crossing Status: Found UCIP Comments: 10/30/2018 Photos of the pipe failure, visible from the LS inlet, were uploaded. Crossing remains Urgent due to the deteriorated condition of the pipe. Recommend internal inspection through the levee. (O. Magana - DWR UCIP)10/18/2018 Unable to access the LS toe due to muddy conditions. Assume no repairs have been done to this crossing to date. This crossing is part of DWR's Deferred Maintenance Project (DMP). Based on the photos taken in 2013 and 2016 the pipe section through the wall has missing pipe sections due to heavy corrosion. Recommend repair to avoid further deterioration of pipe section through levee. Levee is about 8-10 feet high. Crossing remains Urgent based on the deteriorated condition of the pipe on the LS. (O. Magana - DWR UCIP)07/13/2016 Same condition as last. Pipe heavily corroded and partially filled with debris and straw. (K. Fazel - UCIP) 05/15/2013:- mud/soil debris on LS pipe end.- highly corroded pipe in outlet.- may require video inspection or pressure test. (P. Amatya - DWR) FIELD_STRUCT_DESC: 24-inch corrugated metal gravity drainage pipe through the levee, 12.2 feet below the crown. Slide gate in a 36-inch corrugated metal pipe (CMP) riser on the waterside (WS) slope. Concrete headwall at the landside (LS) toe. Pipe crosses under the channel. [Additional Reference(s): DWR Levee Log, 1993]. FS Date: 10/19/2018 8:02:00 AM

WS- slide gate, air vent in CMP riser on levee slope

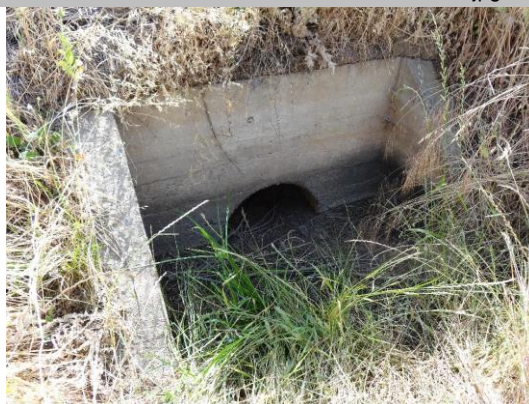
Photo 2 of 3 : UCIP_SP_2019_53425_22045.jpg

LS- CMP in concrete head/wing wall outlet

Comment Code						
Inspector Comment						
FS_ID:53425 DS_ID:22632 EP_NO: N/A Repair Type: Urgent Crossing Status: Found UCIP Comments: 10/30/2018 Photos of the pipe failure, visible from the LS inlet, were uploaded. Crossing remains Urgent due to the deteriorated condition of the pipe. Recommend internal inspection through the levee. (O. Magana - DWR UCIP)10/18/2018 Unable to access the LS toe due to muddy conditions. Assume no repairs have been done to this crossing to date. This crossing is part of DWR's Deferred Maintenance Project (DMP). Based on the photos taken in 2013 and 2016 the pipe section through the wall has missing pipe sections due to heavy corrosion. Recommend repair to avoid further deterioration of pipe section through levee. Levee is about 8-10 feet high. Crossing remains Urgent based on the deteriorated condition of the pipe on the LS. (O. Magana - DWR UCIP)07/13/2016 Same condition as last. Pipe heavily corroded and partially filled with debris and straw. (K. Fazel - UCIP) 05/15/2013:- mud/soil debris on LS pipe end.- highly corroded pipe in outlet.- may require video inspection or pressure test. (P. Amatya - DWR) FIELD_STRUCT_DESC: 24-inch corrugated metal gravity drainage pipe through the levee, 12.2 feet below the crown. Slide gate in a 36-inch corrugated metal pipe (CMP) riser on the waterside (WS) slope. Concrete headwall at the landside (LS) toe. Pipe crosses under the channel. [Additional Reference(s): DWR Levee Log, 1993]. FS Date: 10/19/2018 8:02:00 AM

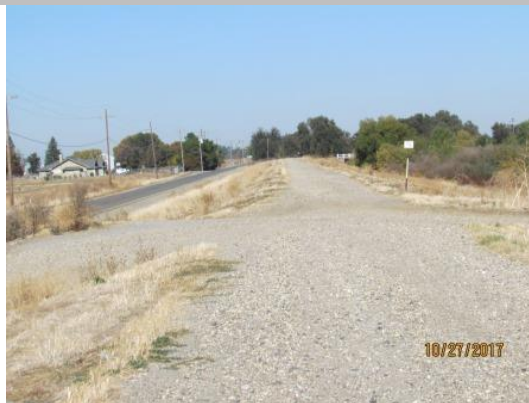
Photo 1 of 1 : SP_2019_RD1001_40_7_20190305_00002.jpg

LM Start	4.04	Rating **	A/W	Issue No.	7
LM End	4.04	Issue Type +	Ma	Location *	CR
Category	Earthen Levee			GPS Latitude/Longitude	
				Start	End
Item	Crown Surface / Depressions / Rutting			38.888803 °	38.888803 °
				-121.524738 °	-121.524738 °
DWR ID	DWR_RD1001_06_s_2012_7				
Comment Code					
C2 : Repair depressions or ruts in the crown or slope.					
Inspector Comment					
There are depressions on the crown where there is cross traffic. Monitor this area and fix as needed.

View of crown where there is cross traffic looking upstream. Monitor this area and fix as needed.

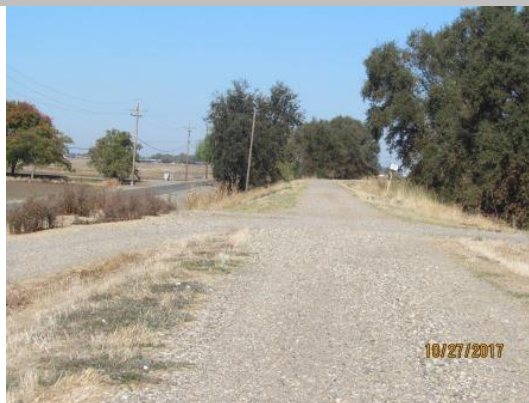
Photo 1 of 1 : SP_2019_RD1001_40_19_20190305_00006.jpg

LM Start	4.33	Rating **	A/W	Issue No.	19
LM End	4.33	Issue Type +	Ma	Location *	CR
Category	Earthen Levee			GPS Latitude/Longitude	
				Start	End
Item	Crown Surface / Depressions / Rutting			38.892999 °	38.892999 °
				-121.524711 °	-121.524711 °
DWR ID	DWR_RD1001_06_f_2013_19				
Comment Code					
C2 : Repair depressions or ruts in the crown or slope.					
Inspector Comment					
There are depressions on the crown where there is cross traffic. Monitor this area and fix as needed.

View of crown where there is cross traffic looking upstream. Monitor this area and fix as needed.

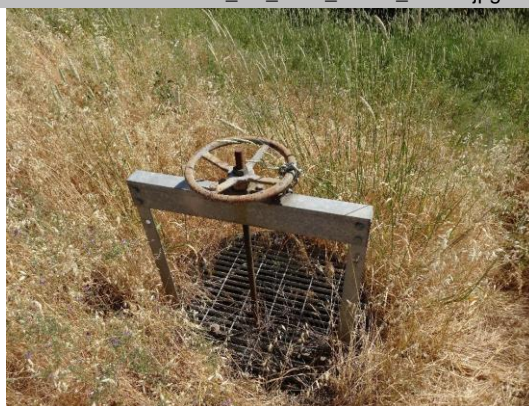
Photo 1 of 3 : UCIP_SP_2019_41724_22034.jpg

LM Start	4.36	Rating **	M	Issue No.	55
LM End	4.36	Issue Type +	En	Location *	
Category	Supplemental			GPS Latitude/Longitude	
				Start	End
Item	DWR UCIP Field Study			38.893448 °	38.893448 °
				-121.524719 °	-121.524719 °
DWR ID	22618				
Comment Code					
Inspector Comment					
FS_ID:41724 DS_ID:22618 EP_NO: N/A Repair Type: Non-Urgent Crossing Status: Found UCIP Comments: 05/15/2013 - damaged head/wing wall in inlet structure. (P. Amatya - DWR UCIP) FIELD_STRUCT_DESC: 30-inch corrugated metal gravity irrigation pipe through the levee, 15.9 feet below the crown. Slide gate in a 36-inch corrugated metal pipe (CMP) riser on the waterward slope. Pipe discharges into a large irrigation ditch on the west side of Pacific Avenue. (Joplin and South Sutter Water District). [Additional Reference(s): DWR Levee Log, 1993]. FS Date: 5/15/2013

WS- slide gate in CMP riser.

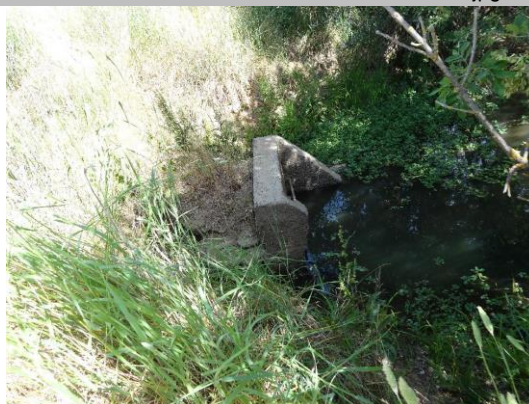
Photo 2 of 3 : UCIP_SP_2019_41724_22033.jpg

WS- inlet wing wall with trashrack

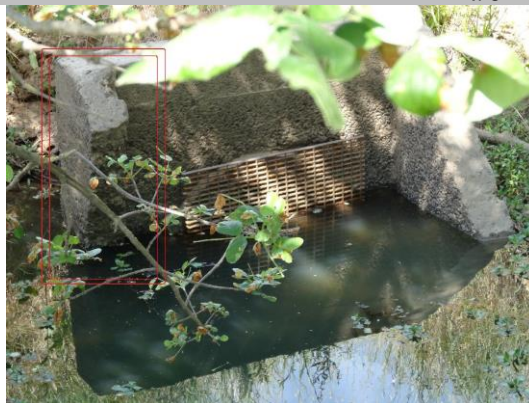
Photo 3 of 3 : UCIP_SP_2019_41724_22032.jpg

LM Start	4.36	Rating **	M	Issue No.	55 (cont)	
LM End	4.36	Issue Type +	En	Location *		
Category	Supplemental			GPS Latitude/Longitude		
				Start		End
Item	DWR UCIP Field Study			38.893448 °		38.893448 °
				-121.524719 °		-121.524719 °
DWR ID	22618					
Comment Code						
Inspector Comment						
FS_ID:41724 DS_ID:22618 EP_NO: N/A Repair Type: Non-Urgent Crossing Status: Found UCIP Comments: 05/15/2013 - damaged head/wing wall in inlet structure. (P. Amatya - DWR UCIP) FIELD_STRUCT_DESC: 30-inch corrugated metal gravity irrigation pipe through the levee, 15.9 feet below the crown. Slide gate in a 36-inch corrugated metal pipe (CMP) riser on the waterward slope. Pipe discharges into a large irrigation ditch on the west side of Pacific Avenue. (Joplin and South Sutter Water District). [Additional Reference(s): DWR Levee Log, 1993]. FS Date: 5/15/2013

WS- inlet pipe with trashrack in a damaged wing wall

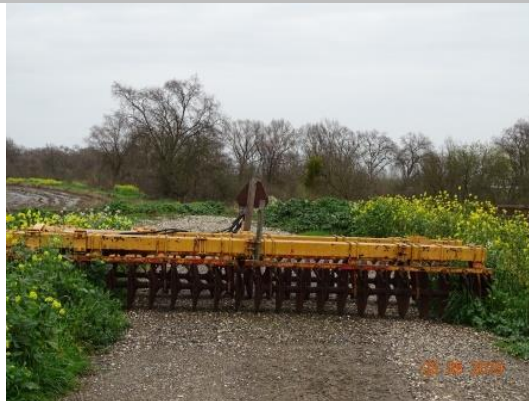
Photo 1 of 2 : SP_2019_RD1001_40_24_20190320_00039.jpg

LM Start	4.71	Rating **	M	Issue No.	24
LM End	4.71	Issue Type +	En	Location *	CR
Category	Earthen Levee			GPS Latitude/Longitude	
				Start	End
Item	Encroachments			38.896310 °	38.896310 °
				-121.520674 °	-121.520674 °
DWR ID	DWR_RD1001_06_f_2016_24				
Comment Code					
EQ : Equipment					
Inspector Comment					
Old piece of pipe still lying on landside levee slope, and equipment on levee crown, Spring 2019.

View looking upstream on crown of a piece of equipment that prohibits access, Spring 2019.
